SERVICE BULLETIN _ FIELD		
Affected Models/Products	T8300 Chassis STB	Customer	V.UK
Subject	BBC New/Extra T2 Muxes Adaption	Date	14.01.2014
Published By	Vestel Customer Support		
TYPE OF MODIFICATION	<input type="checkbox"/> HW MODIFICATION <input type="checkbox"/> BOARD CHANGE <input checked="" type="checkbox"/> OTHER CHANGE		
TECHNICAL CHANGE MODIFICATIONS:			
< Objective >			
<p>T8300 Box can't tune to new BBC Muxes with the current SWs version on devices. Objective is fixing this problem with a SW Update. (New SW version : V2.58)</p>			
< Information >			
<p>This bulletin includes how to SW update T8300 box</p>			
< Instructions >			
Updating the device SW from older version to V2.58 :

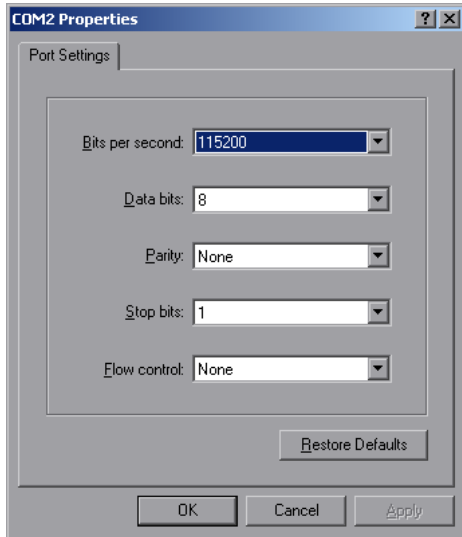
- 2.1) Check DCF ID of the unit according to the list in attachment ([Affected Product Code/Name/DCF ID List](#))
- 2.2) For DCF_1020 ;Download V2.58 Force_Upgrade.bin file from https://www.dropbox.com/sh/r731hslt2bvz3yi/IhPdXjTppQ/DCF_1020
For DCF 1030 ; Download V2.58 Force_Upgrade.bin file from https://www.dropbox.com/sh/r731hslt2bvz3yi/hvkxYKcnIh/DCF_1030
- 2.3) Connect the unit to a PC using RS232 to Scart connector (Unit should be in Power OFF state)
- 2.4) Execute Hyperterminal on PC and adjust the settings as below

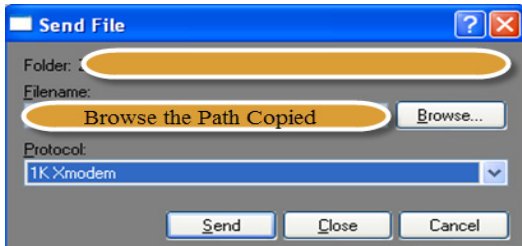
2.5) Hyperterminal → Transfer → SendFile → Browse the file (Force_Upgrade.bin); choose the protocol as 1KXmodem and click Send

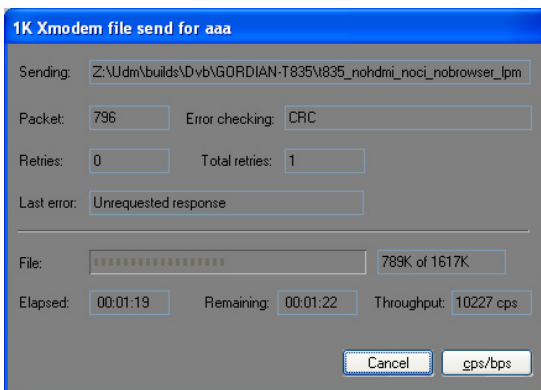
2.6) Power ON the unit. Update will take 2-3 minutes and the notification menu below will appear within this period
